MARINE INVESTIGATION REPORT (AMENDED)

M99F0042

STRIKING OF A DOCK WITH AN UNLOADING BOOM

**THE SELF-UNLOADING BULK CARRIER "ALGOBAY"
POE LOCK, SAULT STE. MARIE, MICHIGAN, UNITED STATES**

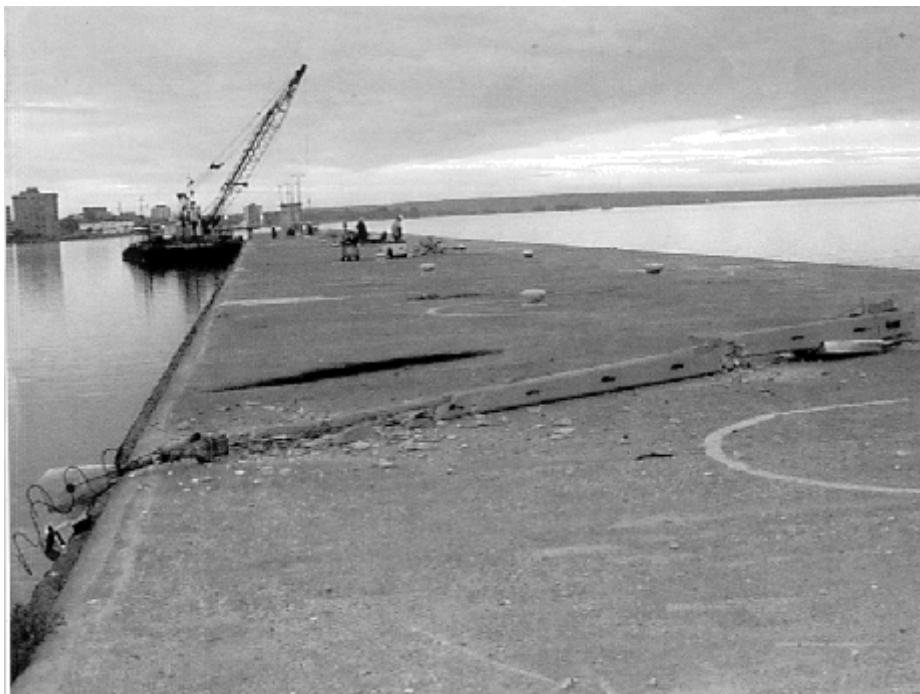
Five light standards on the approach wharf were knocked down and damaged.

Damaged light standards on dock

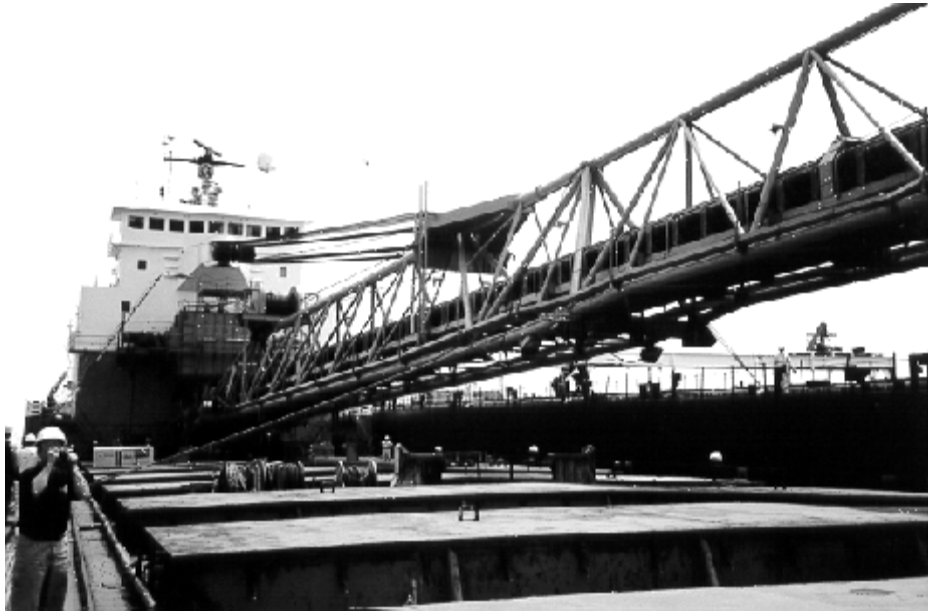
Unloading boom in topped-up position

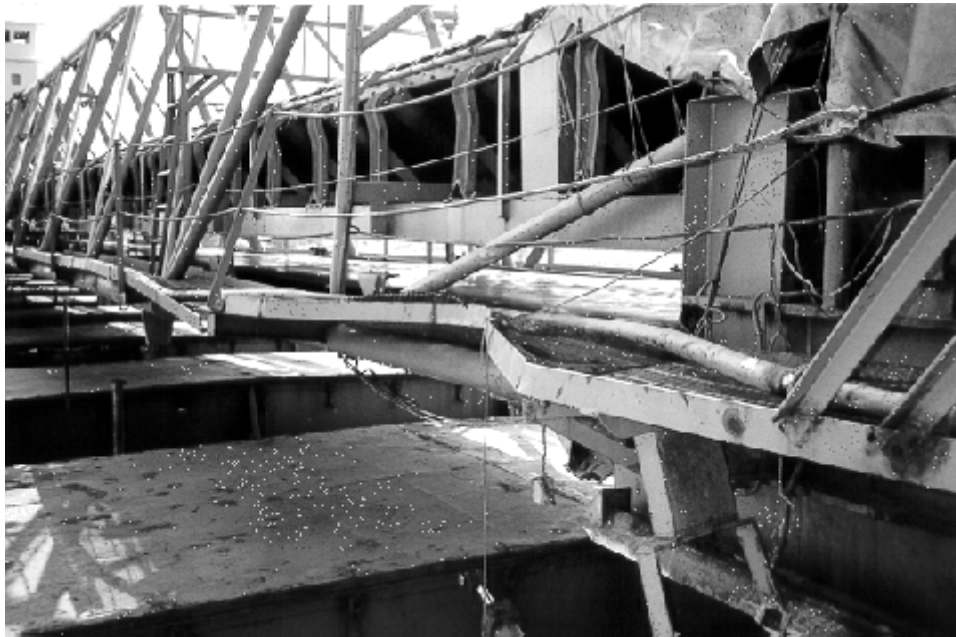
The unloading boom suffered extensive damage to its port forward and starboard after slewing cylinders when air trapped in the hydraulic slewing rams compressed and fractured the cylinders. The unloading hopper was damaged, as were the starboard catwalk and lower longitudinal, which were set in at the point of contact with the light standards.

Unloading boom catwalk: damage from contact with light standards
